Manhole Inspection Summary

Manhole # S35CC1008MH

Insp Date: **12/7/06 9:45 AM**

Location Address: **203 SOUTHWAY**

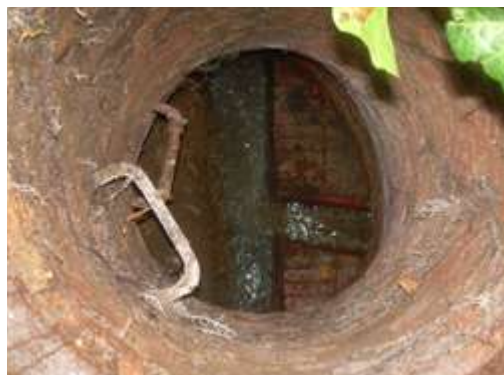
Top View

Corroded steps. Evidence of surcharge - Bench debris.

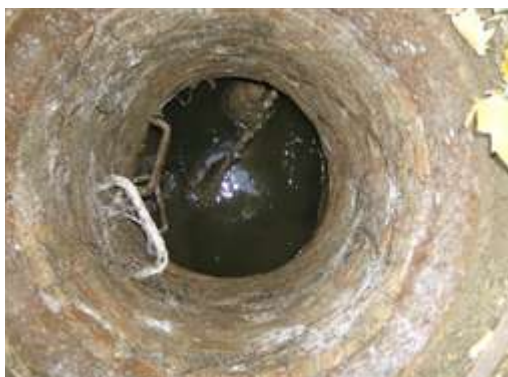
Active surcharge - 1st visit

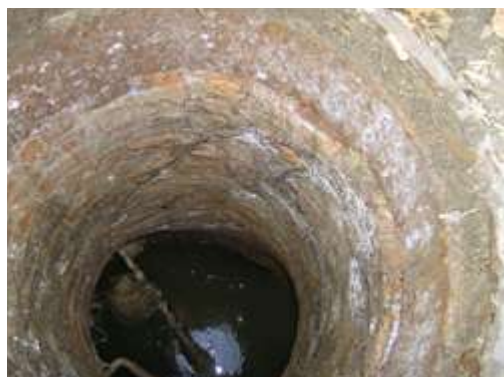
Defect

Adjustment deterioration, loose brick, root intrusion and infiltration. Corbel and Barrel root intrusion and infiltration - other side.

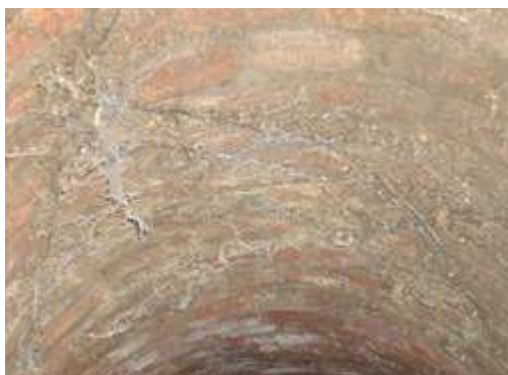
Defect

Adjustment deterioration, loose brick, root intrusion and infiltration. Corbel and Barrel root intrusion and infiltration.

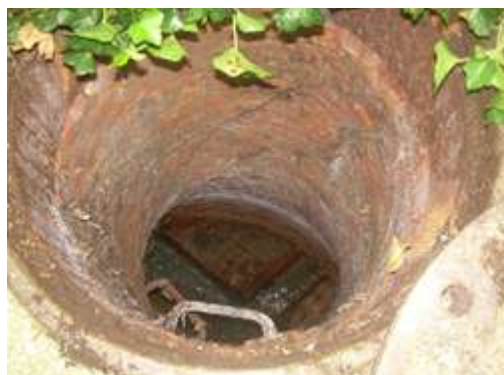
Defect

Adjustment, Corbel and Barrel root intrusion and infiltration.

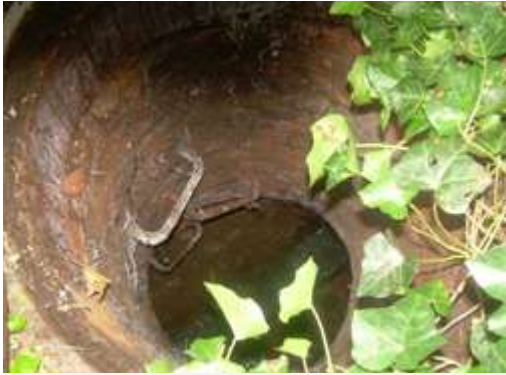
Defect

Adjustment, Corbel and Barrel root intrusion and infiltration - other side.

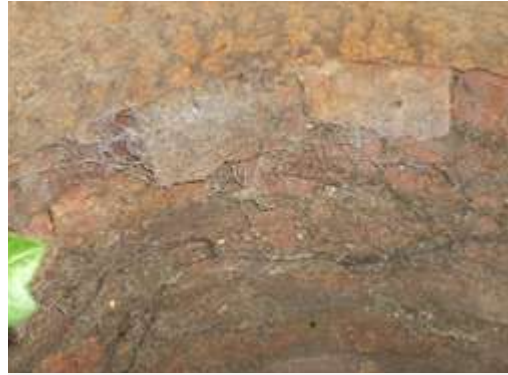
Defect

Adjustment deterioration, loose brick, root intrusion and infiltration.

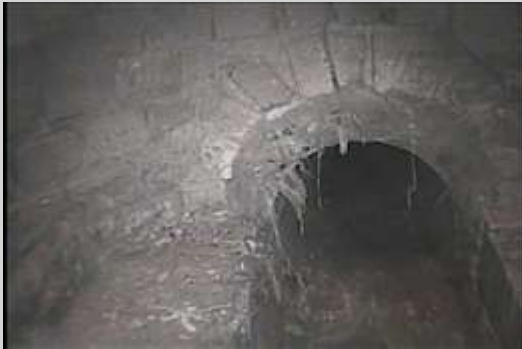
12 in. Circular Gravity Sewer Pipe Out @ 12 O'Clock

Infiltration: **Evidence** Pipe Seal Cond: **Roots**

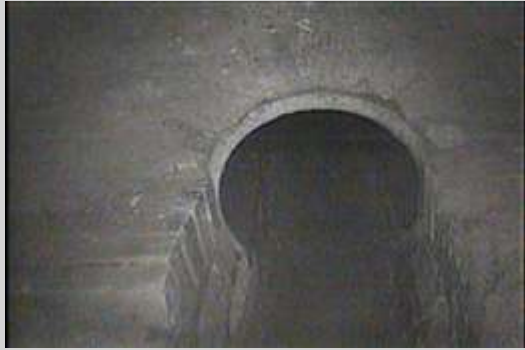
12 in. Circular Gravity Sewer

Infiltration: **Evidence**

Pipe Seal Cond: **Cracked**
